**REPORT NUMBER: 301-MGA-2009-006**

**SAFETY COMPLIANCE TESTING FOR FMVSS 301R  
FUEL SYSTEM INTEGRITY – REAR IMPACT**

**VOLKSWAGEN AG GERMANY  
2009 VOLKSWAGEN GTI  
NHTSA NUMBER: C95801**

**PREPARED BY:  
MGA RESEARCH CORPORATION  
5000 WARREN ROAD  
BURLINGTON, WI 53105**

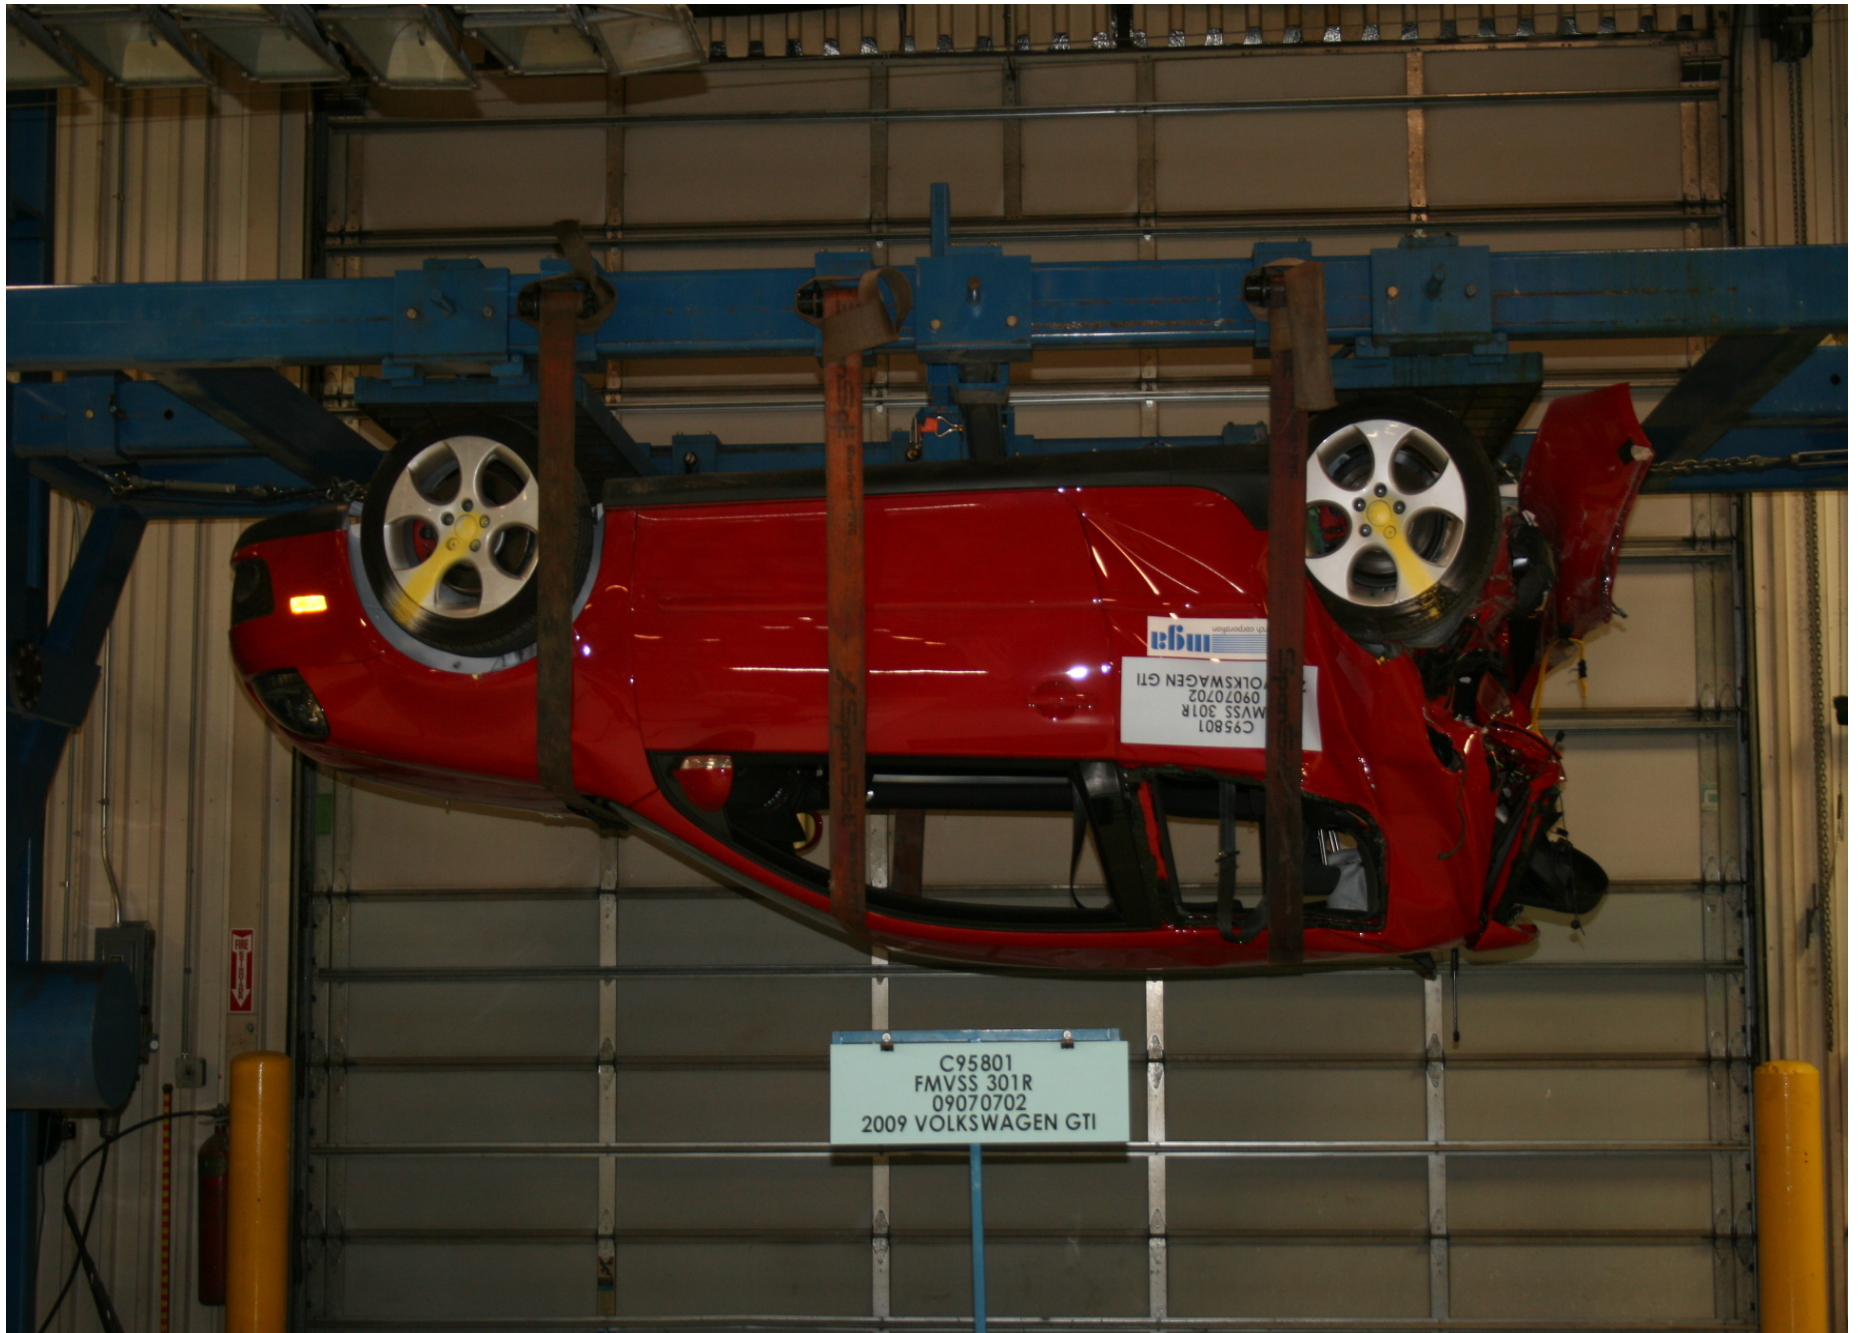
Static Rollover at 180 Degrees

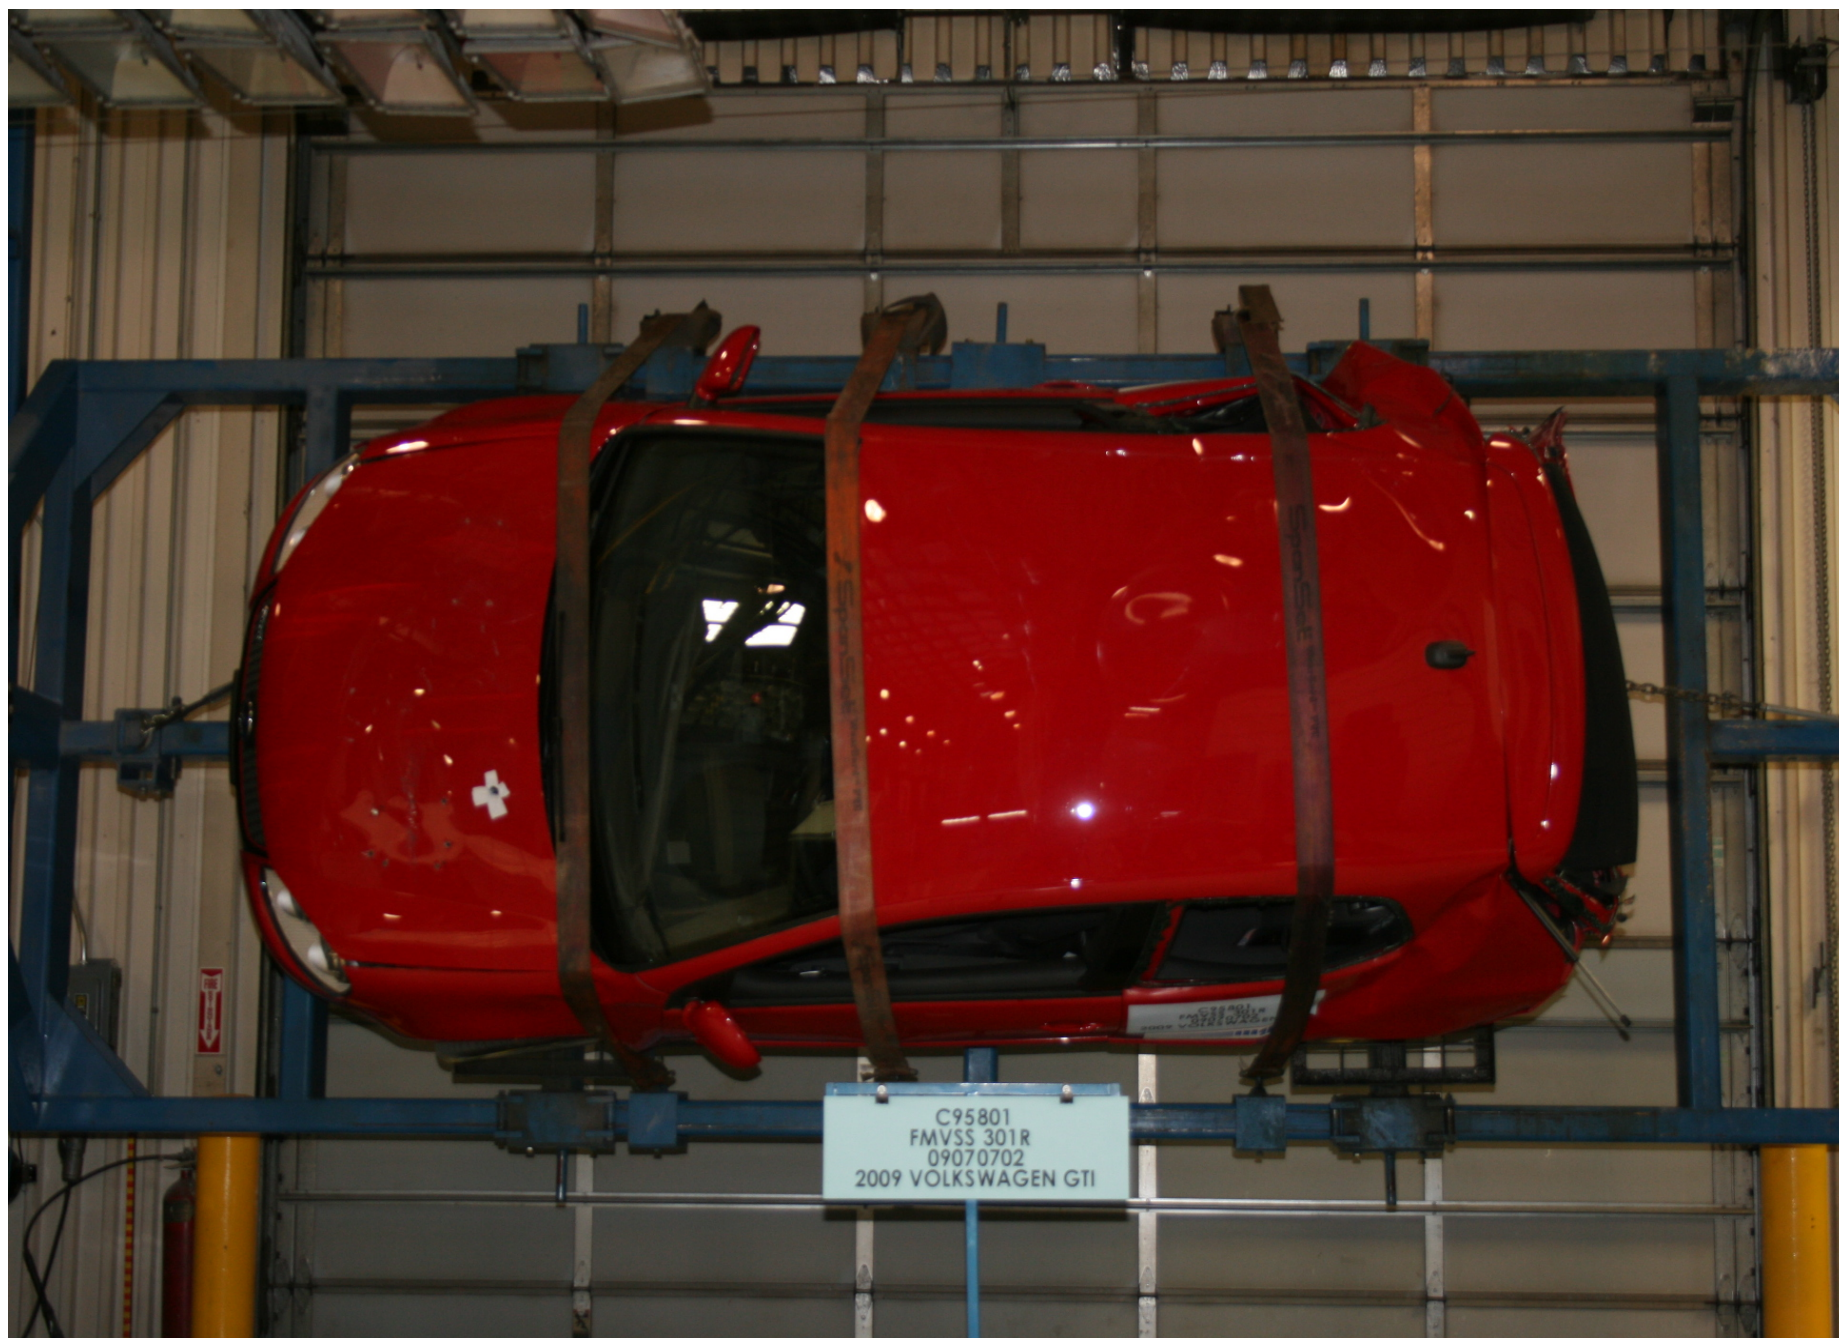
Static Rollover at 270 Degrees

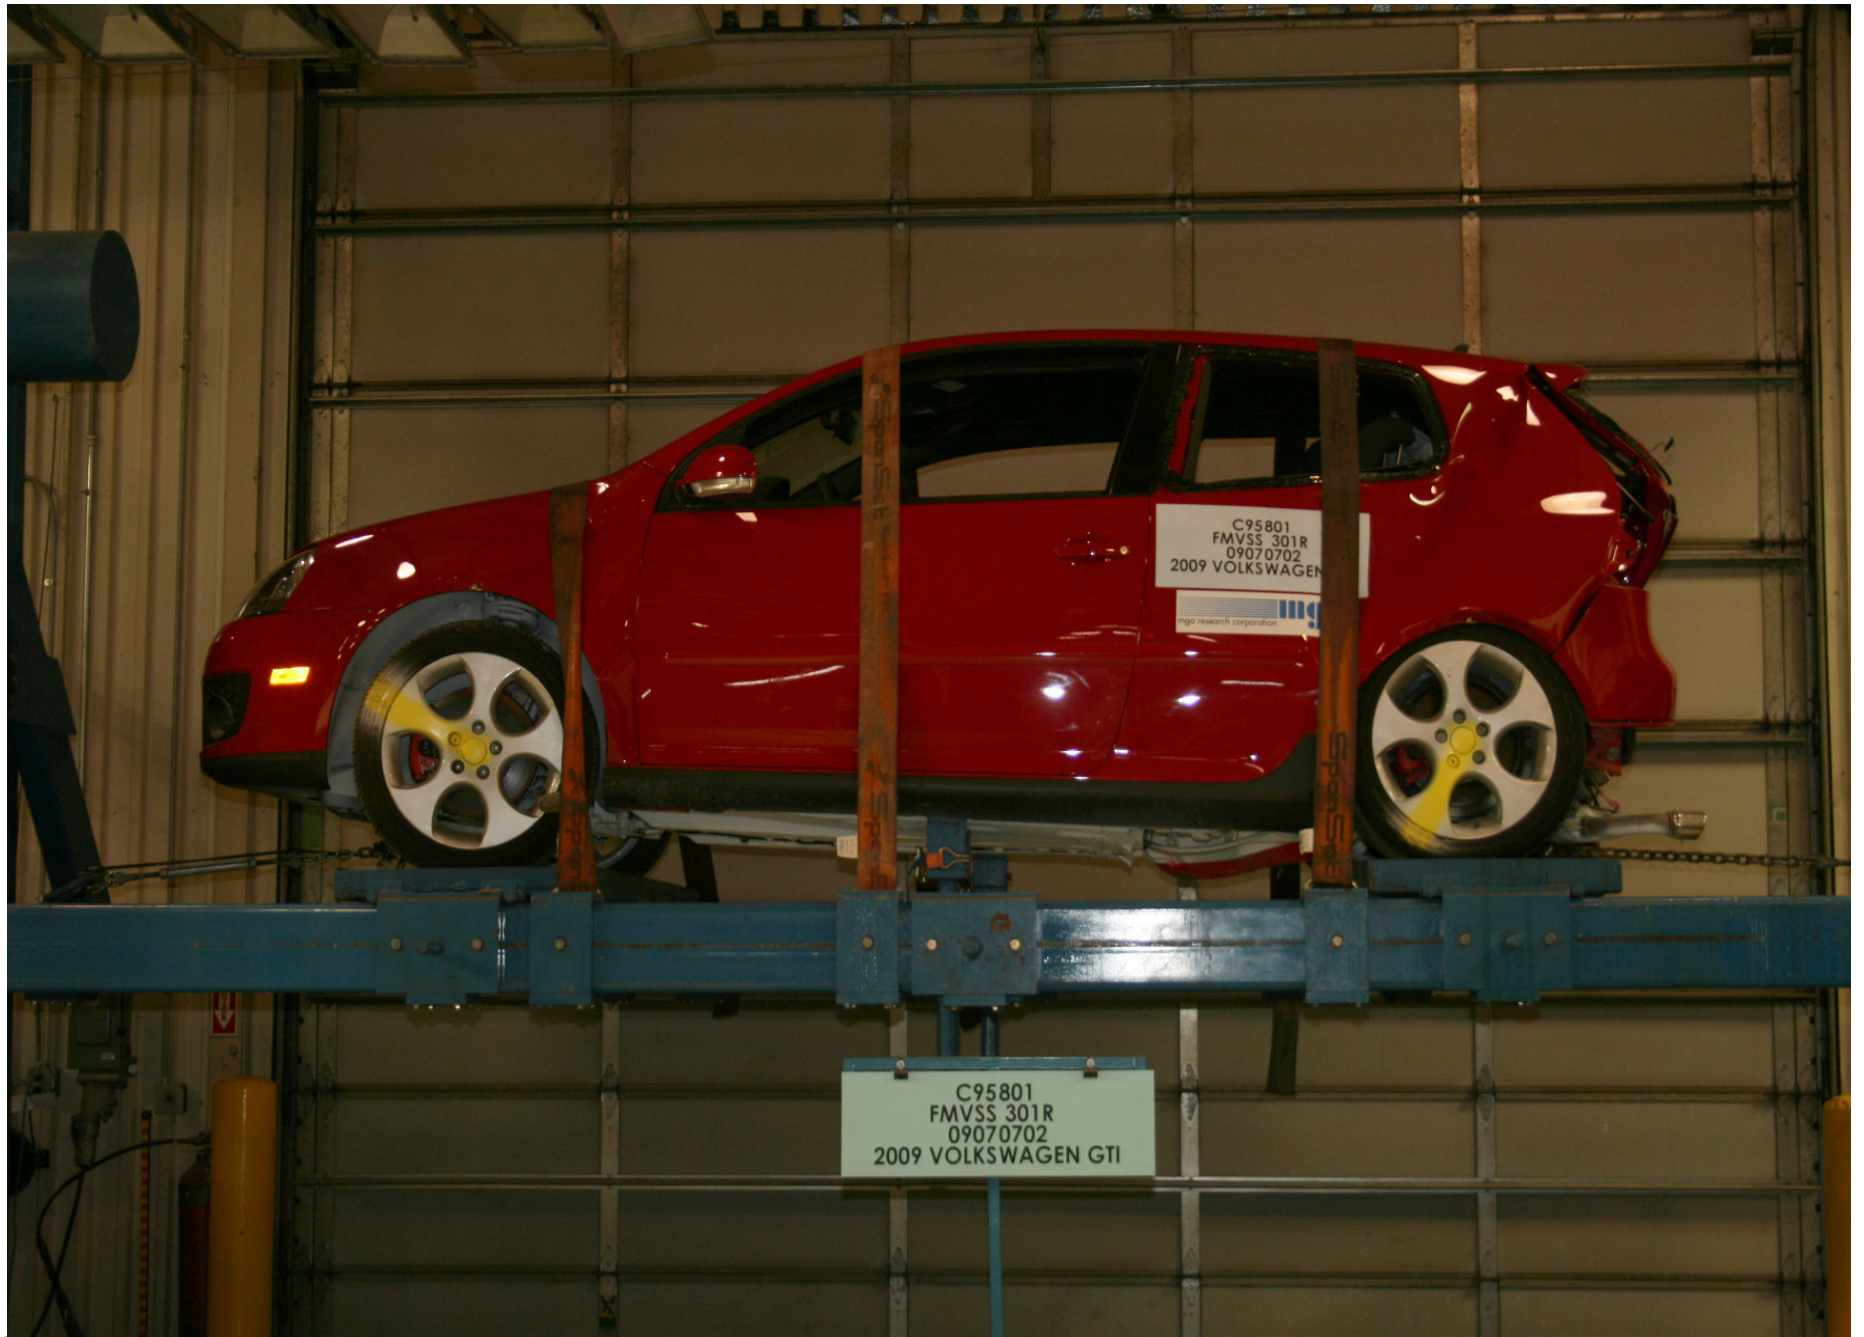
A-40.

Static Rollover at 360 Degrees
